Errata Sheet

RV-8803-C7

Silicon Limitation

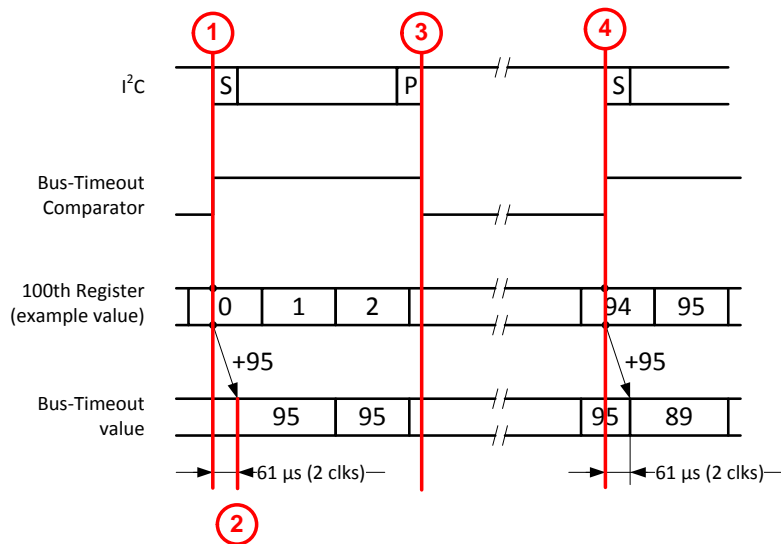
Initialization of the I²C Interface Bus-Timeout by RV-8803-C7:

1. At START condition, the Bus-Timeout Comparator is enabled.
2. It takes 2 clocks 32'768 Hz (61 μs) to read the value of the 1/100th seconds, adding 95/100th and write this as a Bus-Timeout target into the comparator.
3. At STOP condition, the comparator is disabled.
4. At the consecutive START (after STOP), the comparator is enabled with previous Bus-Timeout target value before the next value is calculated and written into the comparator.

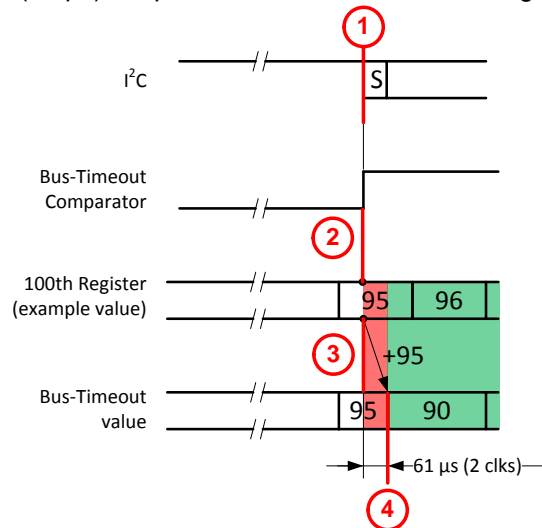
Erroneous Bus-Timeout Reset Scenario 1: New START exactly 950 ms after previous START.

1. At START condition, the comparator is enabled.
2. At the consecutive START the comparator is enabled with previous Bus-Timeout target value.
3. If the actual 1/100th of Second matches with the previous Bus-Timeout target value, a RESET of the I²C Interface will be triggered immediately.
4. It takes 2 clocks 32'768 Hz (61 μs) to update the new Bus-Timeout target value.

Summarized: At START condition of the I²C Interface the Bus-Timeout comparator is enabled. If there is a match between the current value in the 1/100th Seconds register and the previous Bus-Timeout value, the comparator triggers an I²C Bus-Timeout RESET and the RV-8803-C7 will reply immediately with “no acknowledge”.

It's recommended to follow I²C standard protocol and check ACK "acknowledge". When "no acknowledge" is detected, repeat communication procedure beginning with I²C Start.

Workaround: Repeat I²C communication procedure maximum 4 x times.

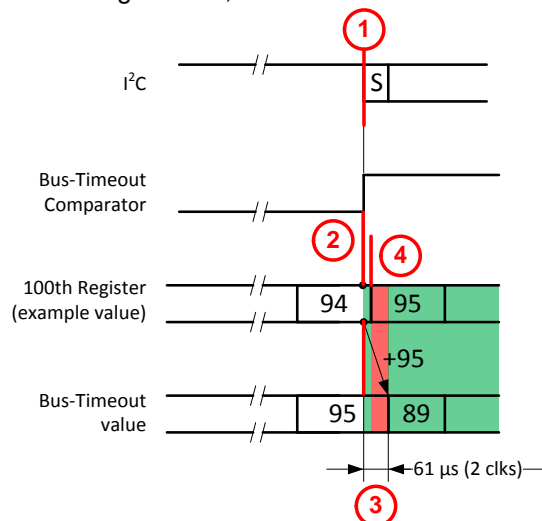
Erroneous Bus-Timeout Reset Scenario 2: New START shortly before 950 ms after previous START

1. At START condition, the comparator is enabled.
2. At the consecutive START the comparator is enabled with previous Bus-Timeout target value. As long as no match with the current 1/100th second is detected no RESET will be triggered.
3. It takes 2 clocks 32'768 Hz (61 μs) to update the new Bus-Timeout target value.
4. If during the 61 μs required for up-dating the Bus-Timeout value the 1/100th of Second is incremented and match the previous Bus-Timeout target value, the I²C Interface will be RESET.

Summarized: At START condition of the I²C Interface the Bus-Timeout comparator is enabled. The 1/100th Seconds register might have the value “previous Bus-Timeout value less one” and the RV-8803-C7 will replay with acknowledge. As soon as the there is a match between the current value in the 1/100th Seconds register and the previous set Bus-Timeout value, the comparator triggers an I²C Bus-Timeout RESET and the RV-8803-C7 will reply with “no acknowledge”.
